CONCEPTUAL SITE MODEL  
FORMER MONTROSE AND STAUFFER FACILITIES  
HENDERSON, NEVADA

**SITE PLAN AND  
SITE ASSESSMENT AREAS**

**FIGURE 2-2**

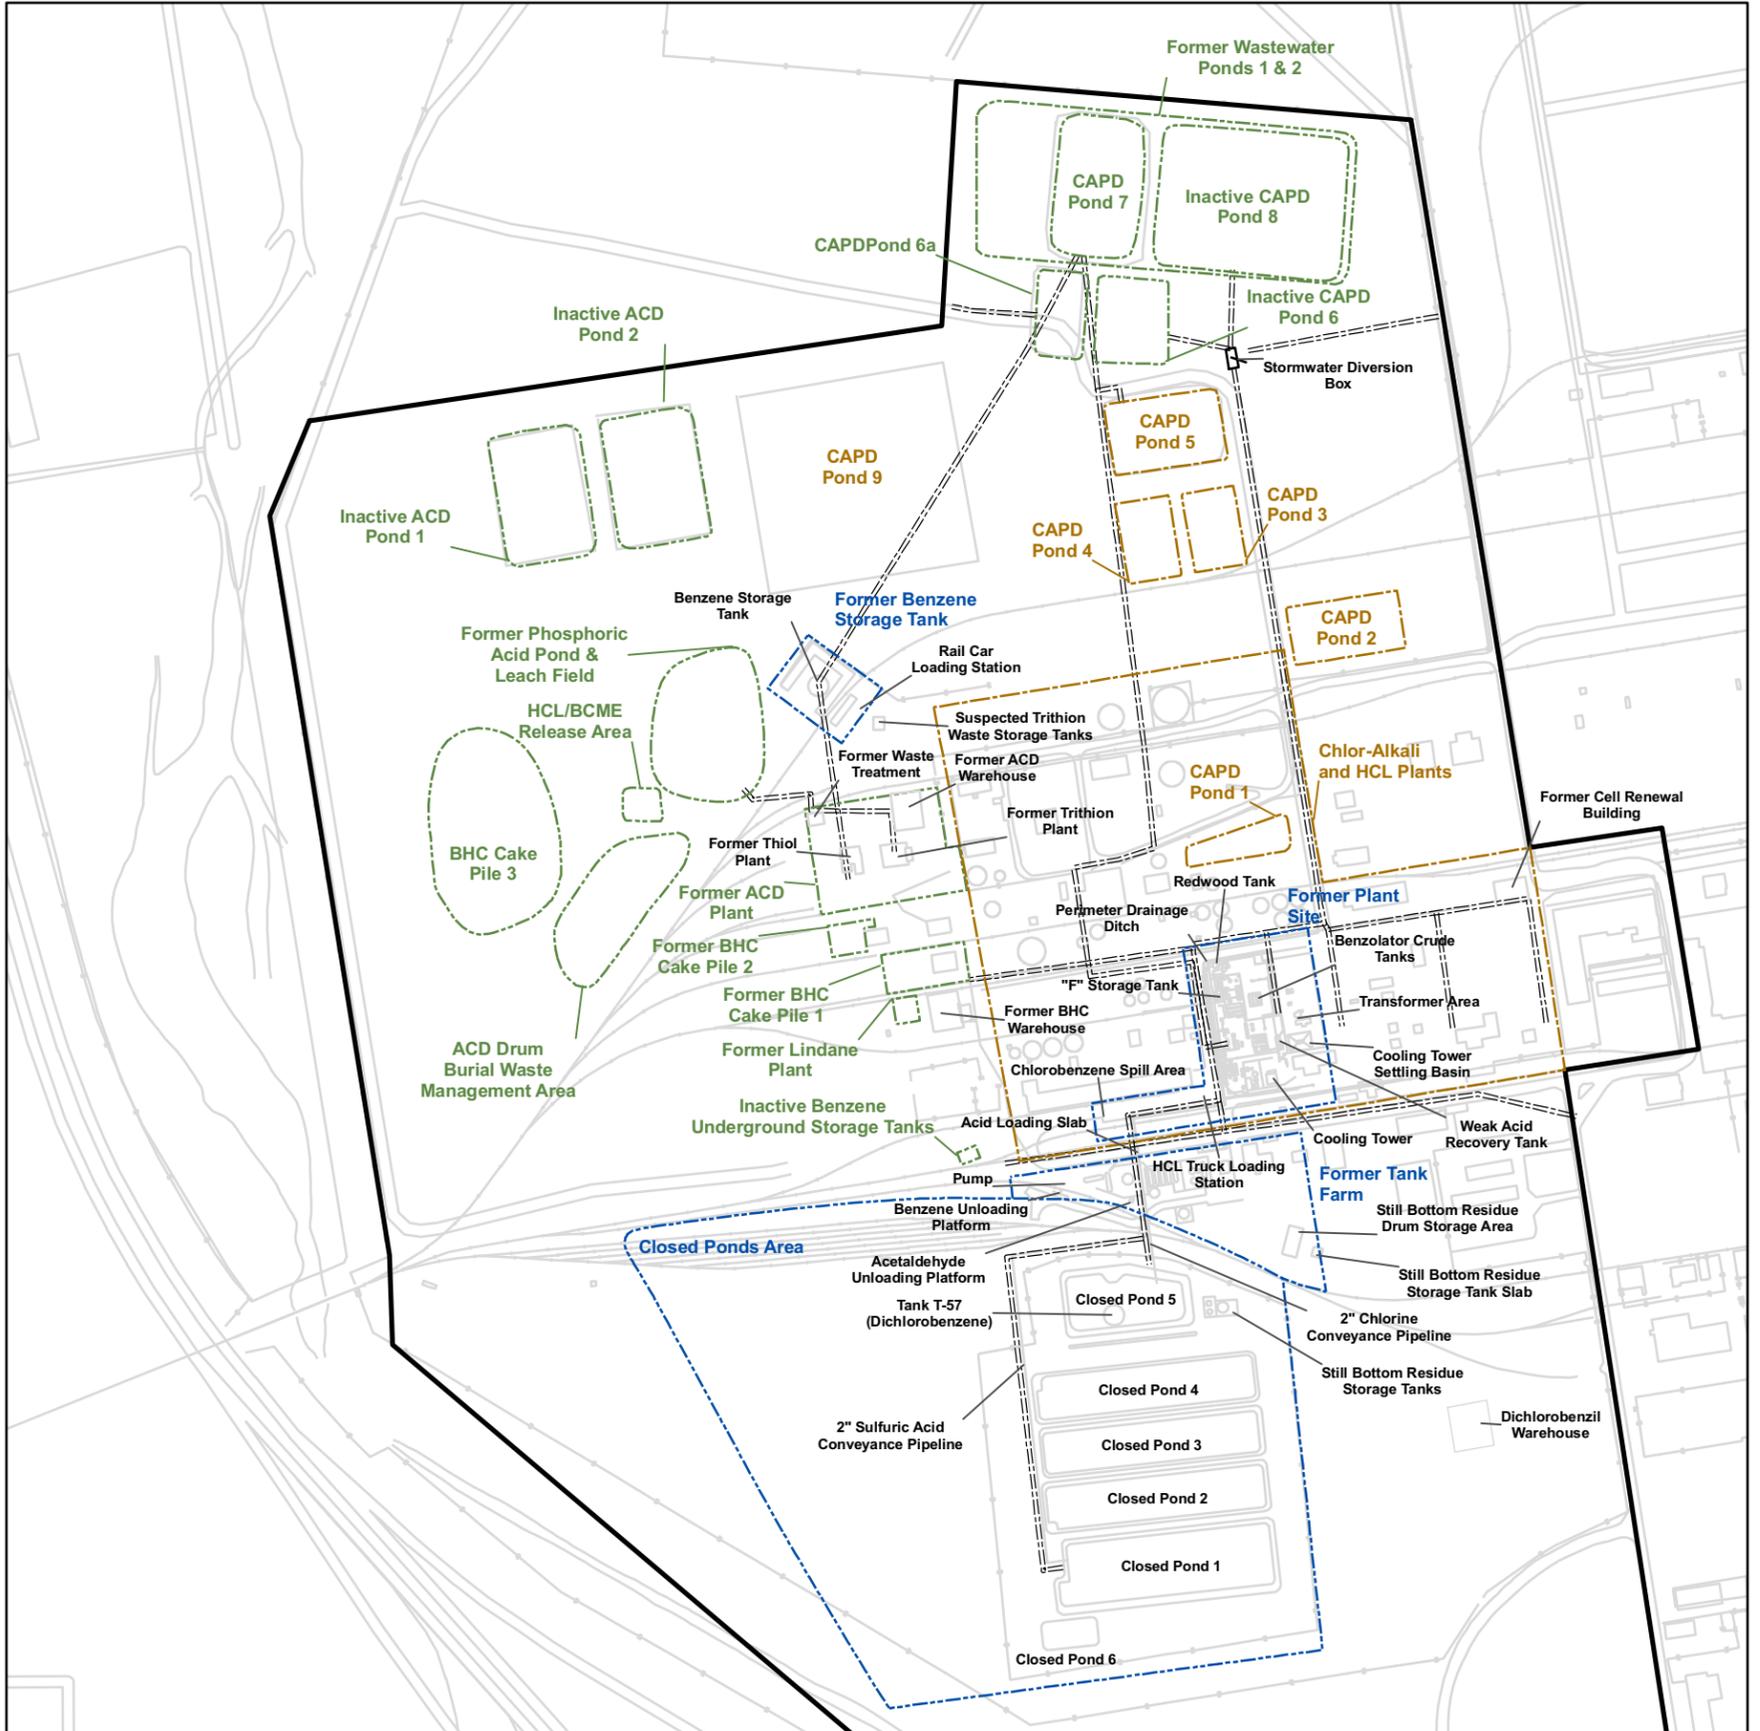
SITE ASSESSMENT AREAS/LETTER OF UNDERSTANDING STUDY ITEMS FOR THE FORMER MONTROSE FACILITY		
Site Assessment Area	LOU Study Item No.	Description
Former Plant Site	1	Process Sewer System
	2	Former Organic Chemical Manufacturing Plant Site
	4	Hydrochloric Acid Truck Loading Station
	5	Release from "F"- Storage Tank (1982)
	13	Plant Perimeter Drain Ditch
	14	Stormwater Sewer System
	20	Redwood Tank
	22	Settling Basin
Closed Ponds	6	Spill of Still Bottom Residues (1981) and Still Bottom Residue Storage Tank Area
	15	Ponds 1, 3, and 4 and associated 2-inch Waste Line
	16	Ponds 2 and 5 (RCRA closed ponds)
	17	Pond 6
Former Tank Farm	18	Still Bottom Residue Drum Storage Area
	19	Tank Farm
Former Benzene Storage Tank	3	Railcar Loading Area near Benzene Storage Tank
	21	Benzene Storage Tank on Parcel C
Site-Wide Groundwater	Site-Wide	Site-Wide

LETTER OF UNDERSTANDING STUDY ITEMS FOR THE FORMER STAUFFER FACILITY	
LOU Study Item No.	Description
4 & 9	Former Leach Field and Phosphoric Acid Pond and Trenches
5	Agricultural Chemicals Division (ACD) Drum Burial Waste Management Area
6	Former Wastewater Ponds 1 and 2
7	Inactive ACD Ponds 1 and 2
8	Former ACD Plant
10	Former Lindane Plant
11	Former Cell Renewal Building Area and Associated Conveyance Facilities
12	Former Benzene Hexachloride (BHC) Cake Piles 1 and 2, Former BHC Loader Haul Route, and BHC Cake Pile 3
20	Inactive CAPD Pond 6
21	CAPD Pond 7
22	Inactive CAPD Pond 8
29	Former HCL/bischloromethylether Release Area
30	Inactive Benzene Underground Storage Tanks
