**PHASE I ENVIRONMENTAL SITE ASSESSMENT
AND LIMITED ASBESTOS AND LEAD-BASED
PAINT SURVEYS
BOB RUUD COMMUNITY CENTER
150 NORTH HIGHWAY 160
PAHRUMP, NEVADA**

PROJECT NO. 117801.01

June 29, 2011

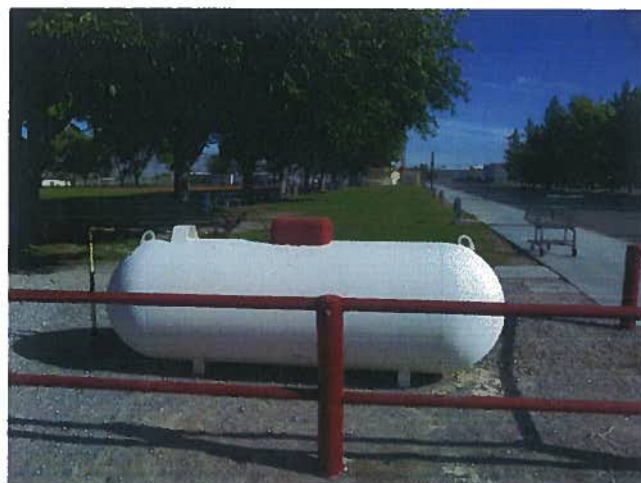
Above ground Propane tank

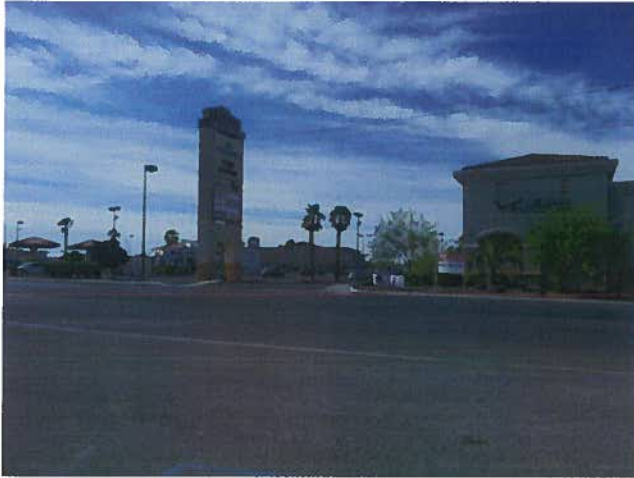
Adjacent property – shopping center with Rebel Oil Fuel Station

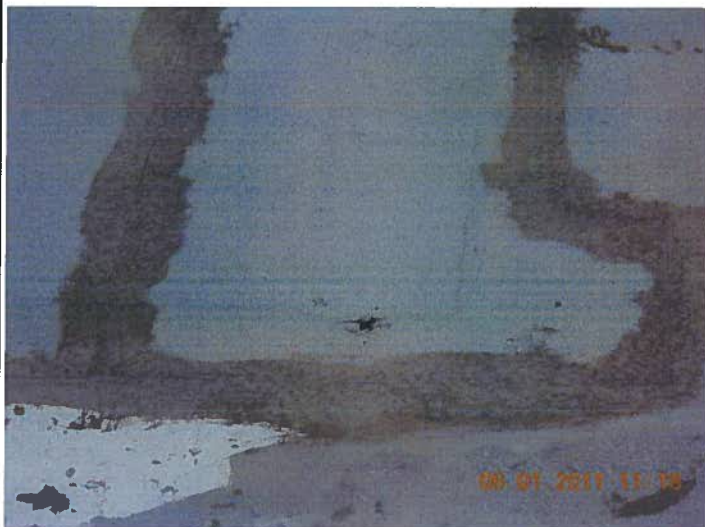
Picture 13. Roofing sample.

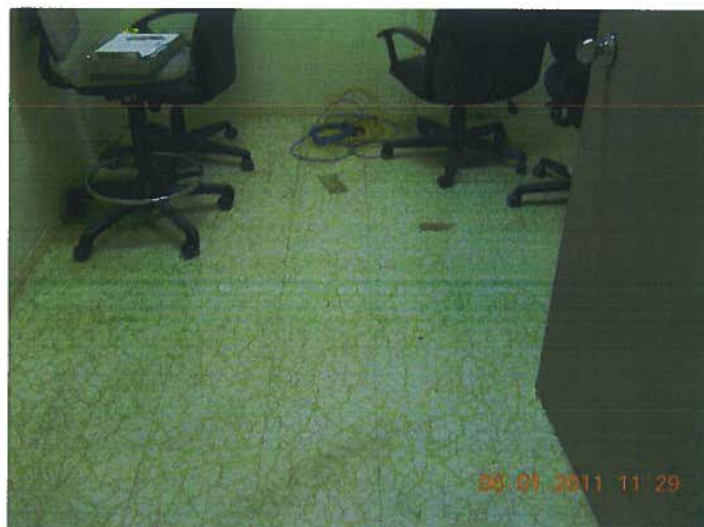
Picture 14. White/Beige vinyl tile.

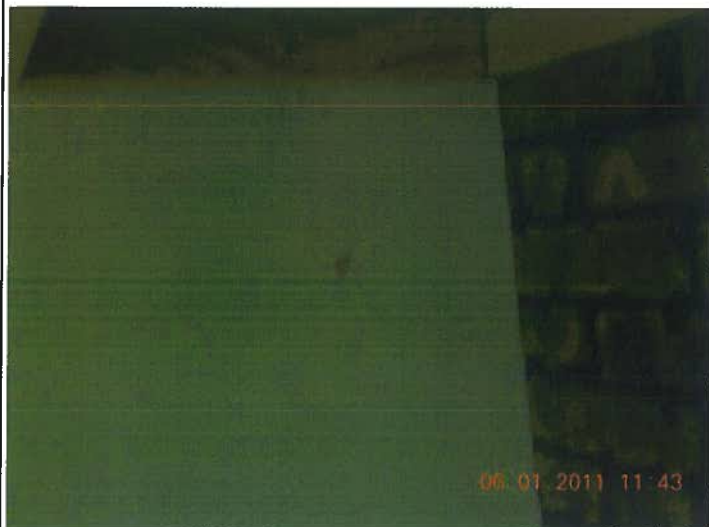
Picture 17. Wallboard sample.

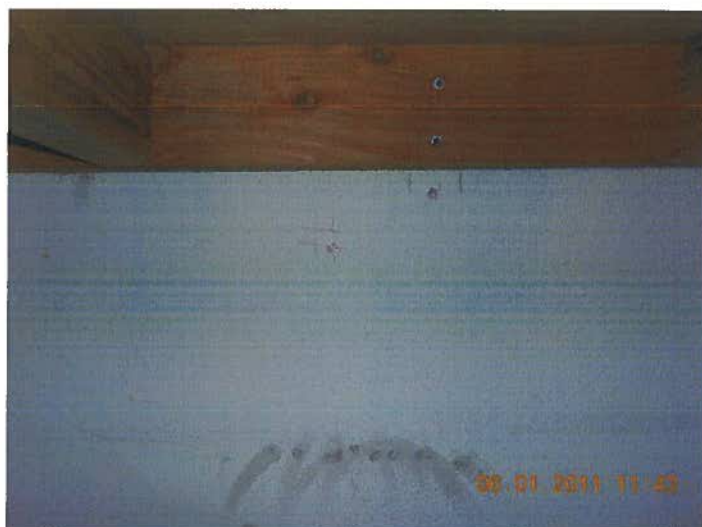
Picture 18. Wallboard sample.

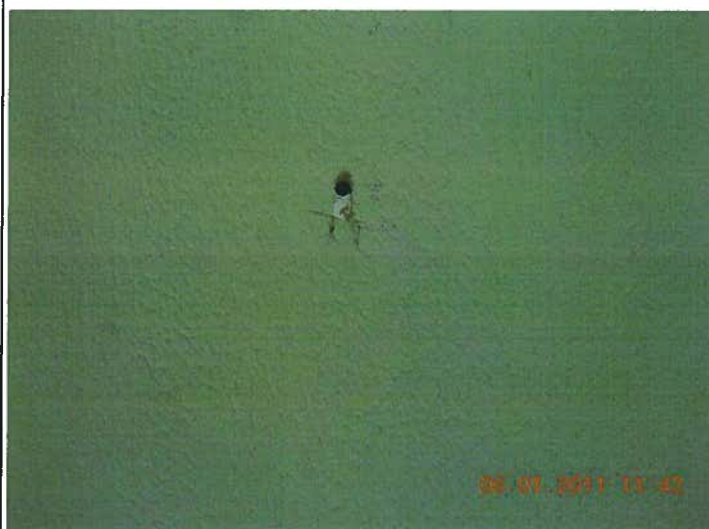
Picture 19. Wallboard sample.

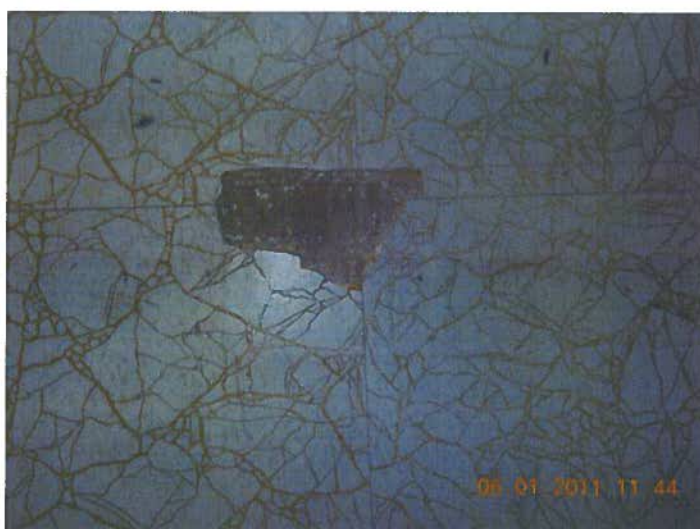
Picture 20. White/Beige tile sample.

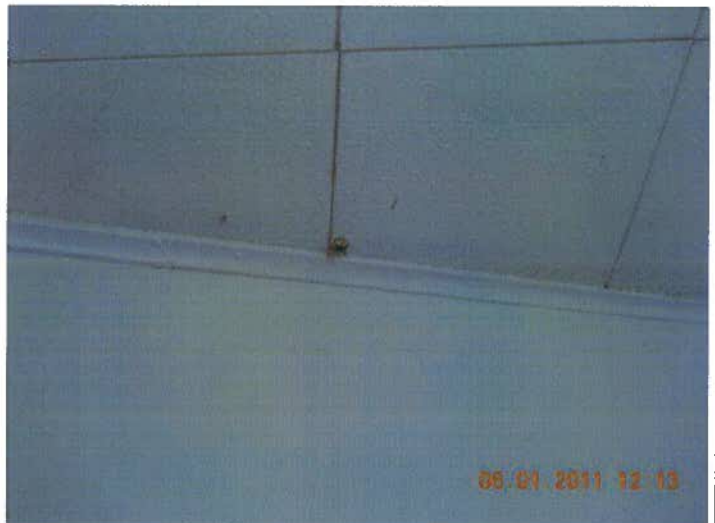
Picture 28. Ceiling sample.

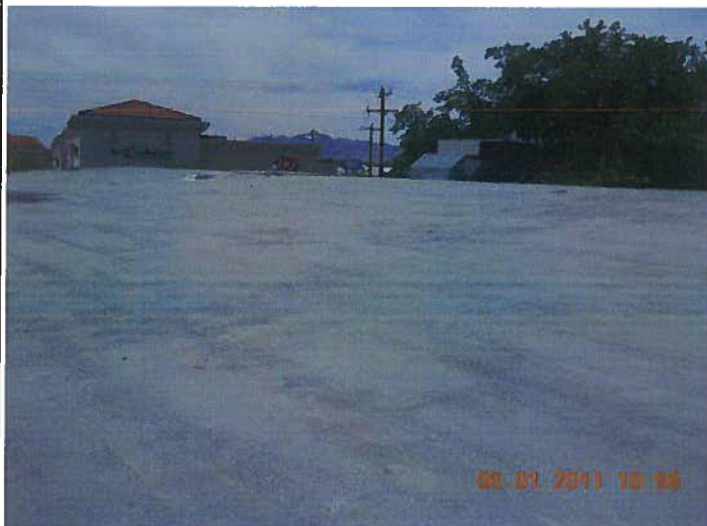
Picture 1. Roofing.

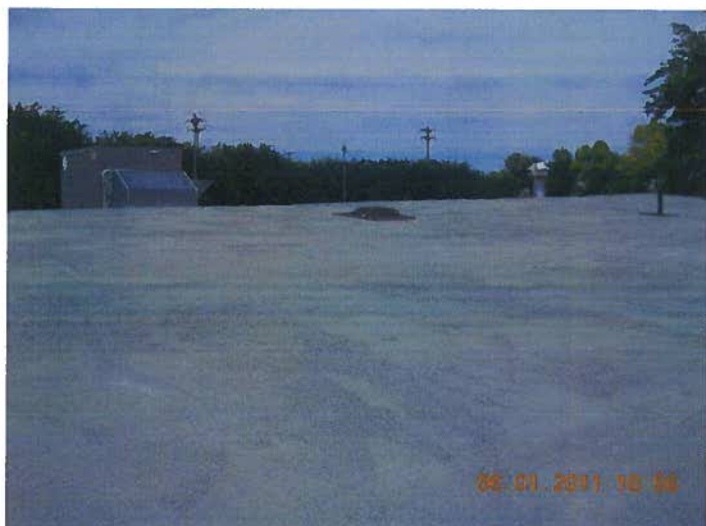
Picture 2. Roofing.

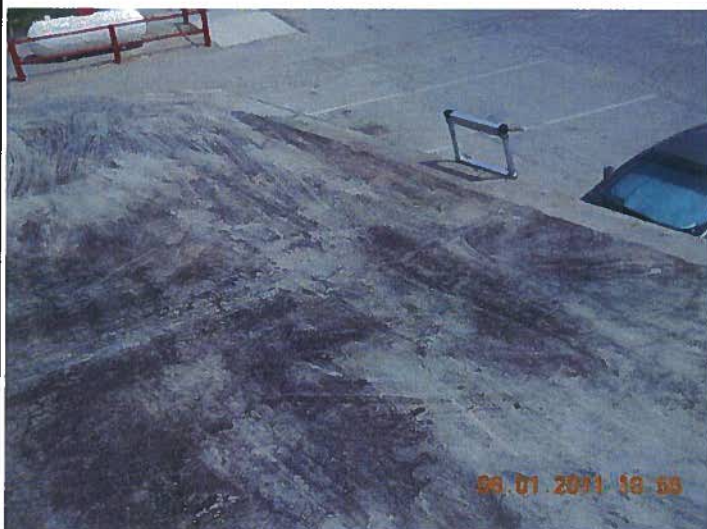
Picture 3. Roofing.

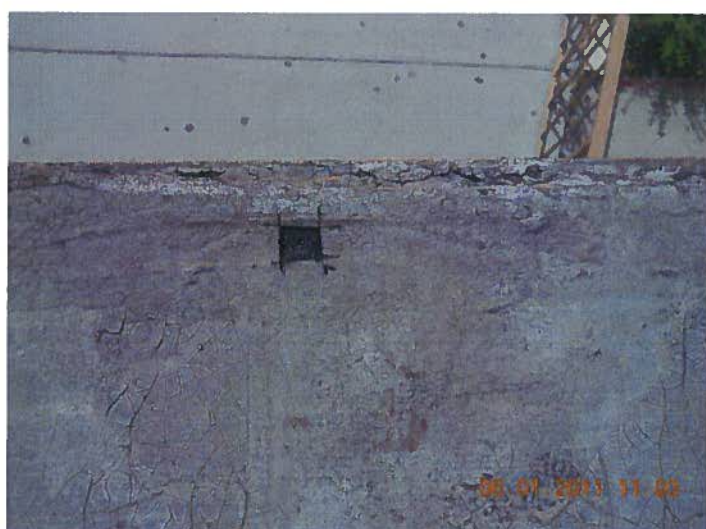
Picture 4. Roofing sample.

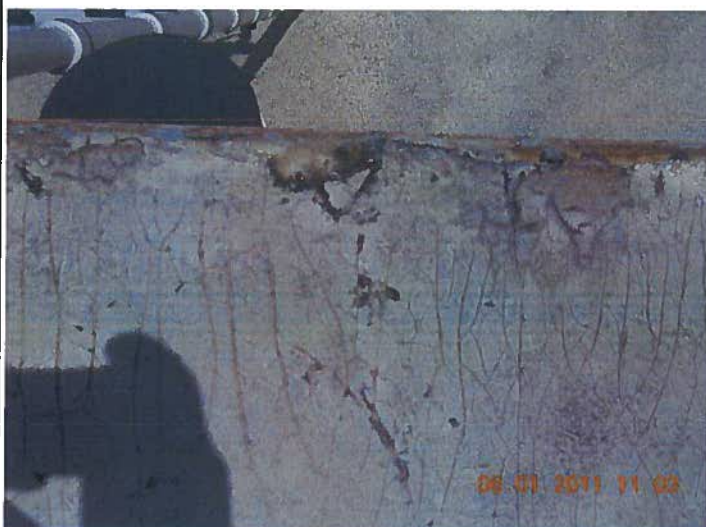
Picture 5. Roofing.

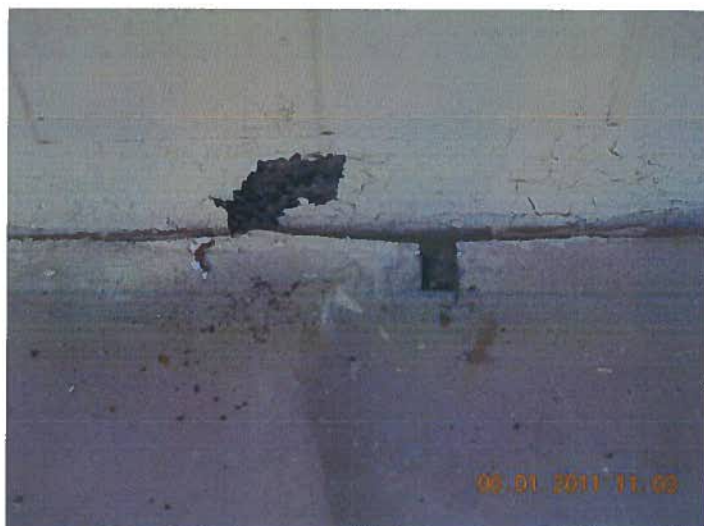
Picture 6. Roofing sample.

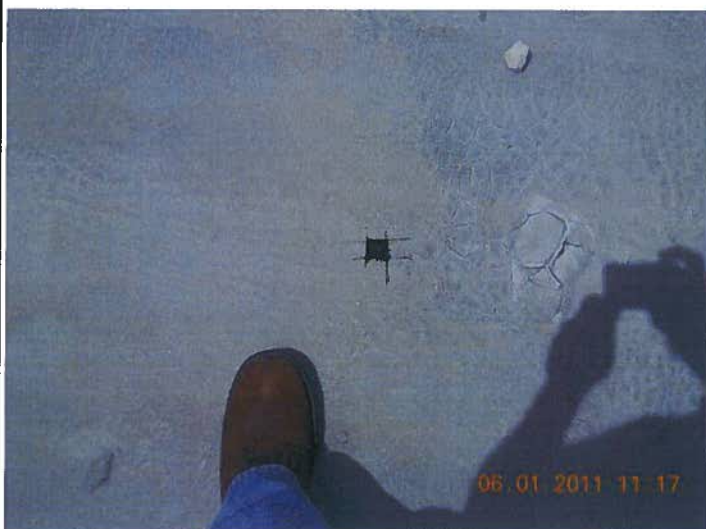
Picture 7. Roofing sample.

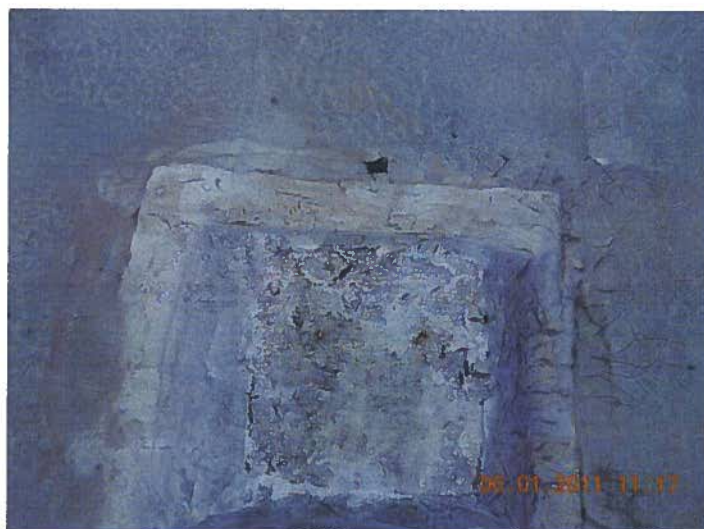
Picture 8. Roofing sample.

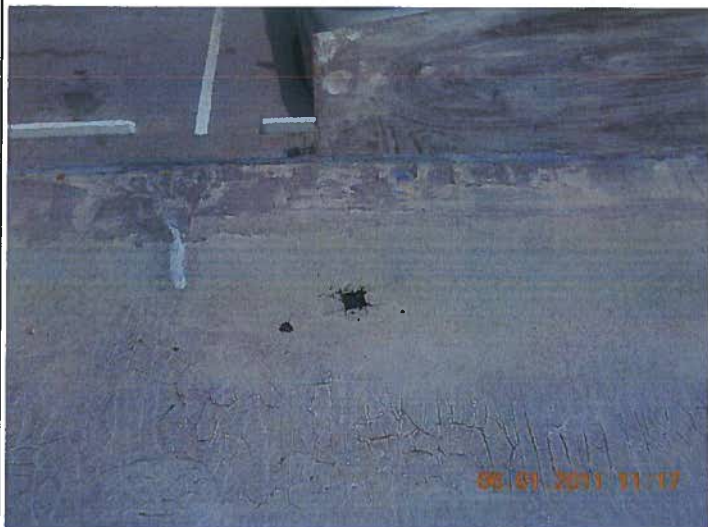
Picture 9. Roofing sample.

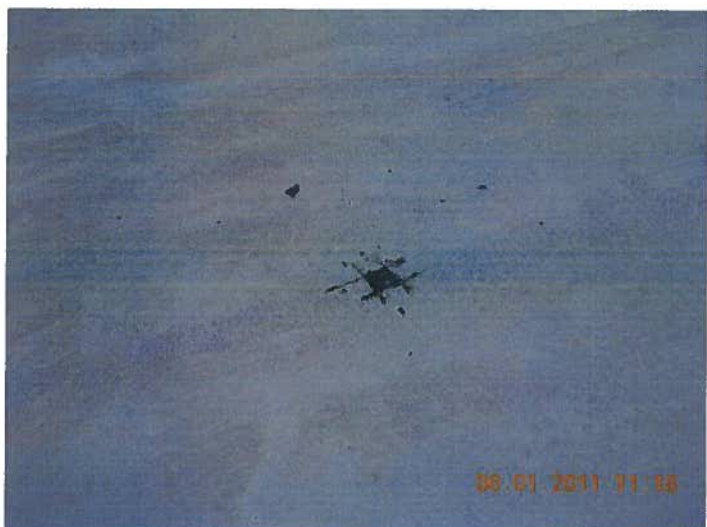
Picture 10. Roofing sample.

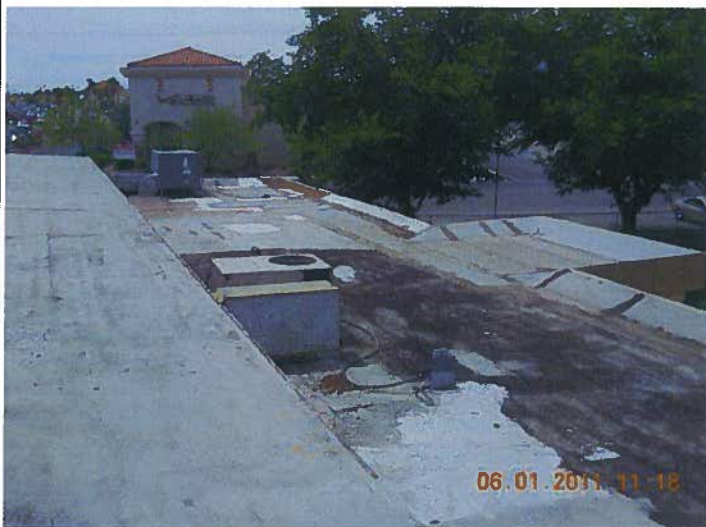
Pictures 11. Roof.

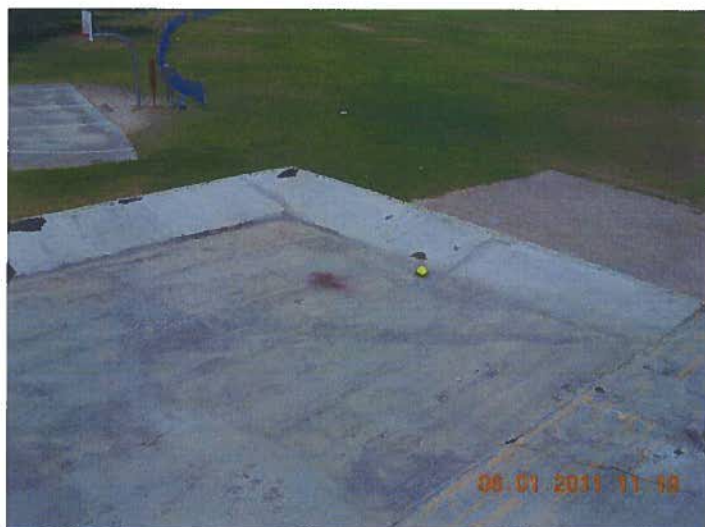
Pictures 12. Roof.

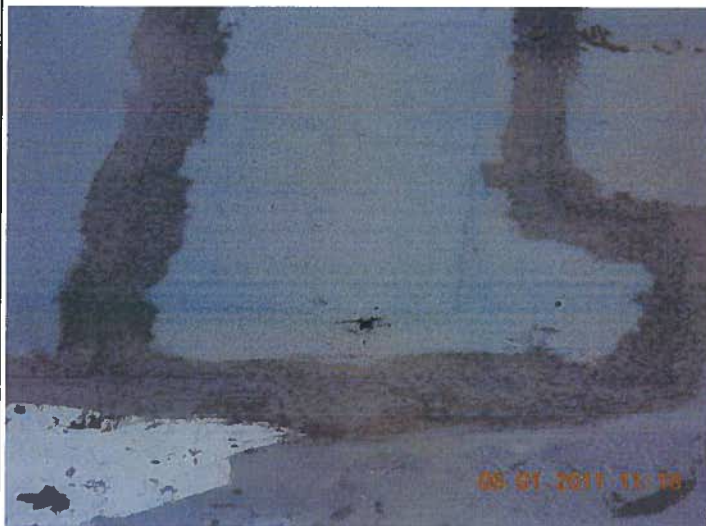
Picture 13. Roofing sample.

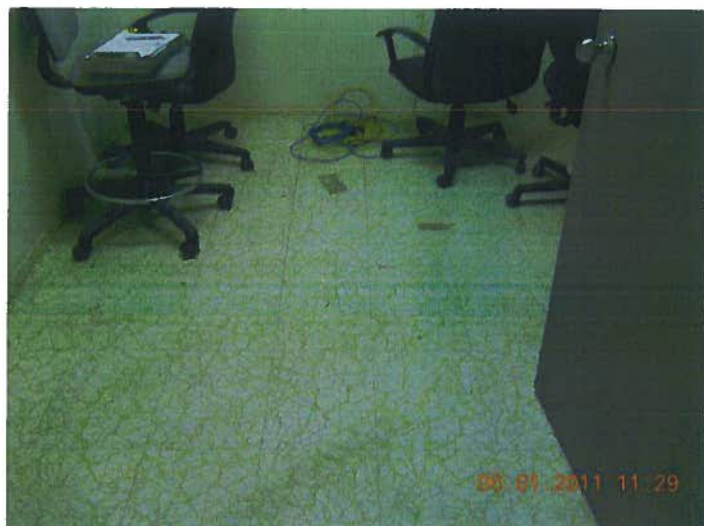
Picture 14. White/Beige vinyl tile.

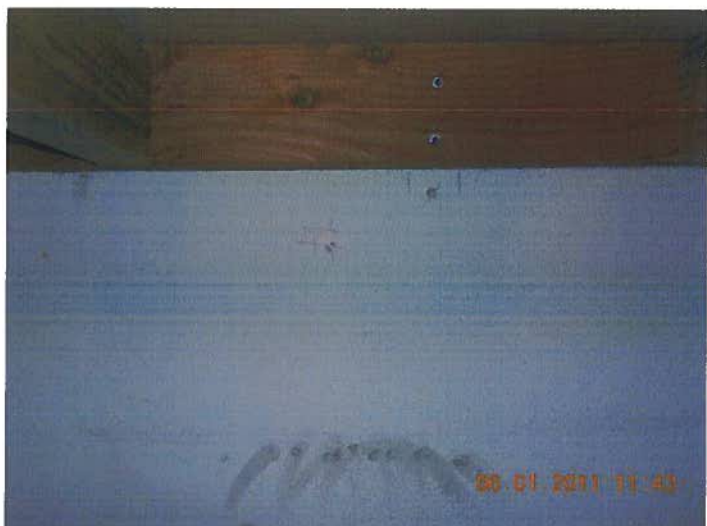
Picture 18. Wallboard sample.

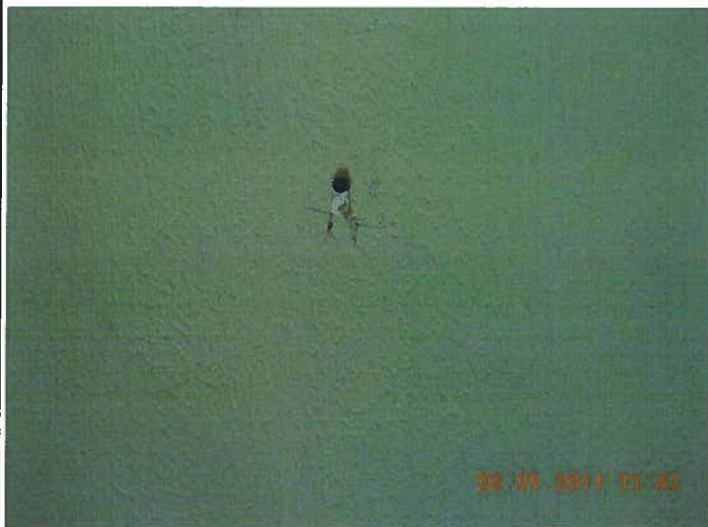
Picture 19. Wallboard sample.

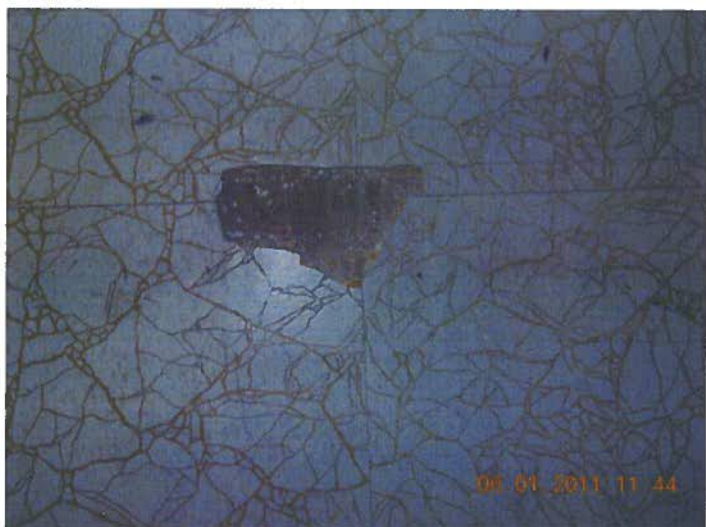
Picture 20. White/Beige tile sample.

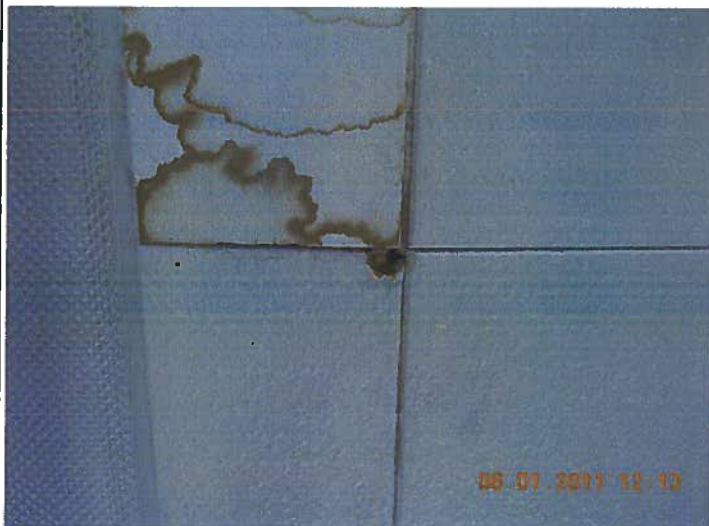
Picture 28. Ceiling sample.

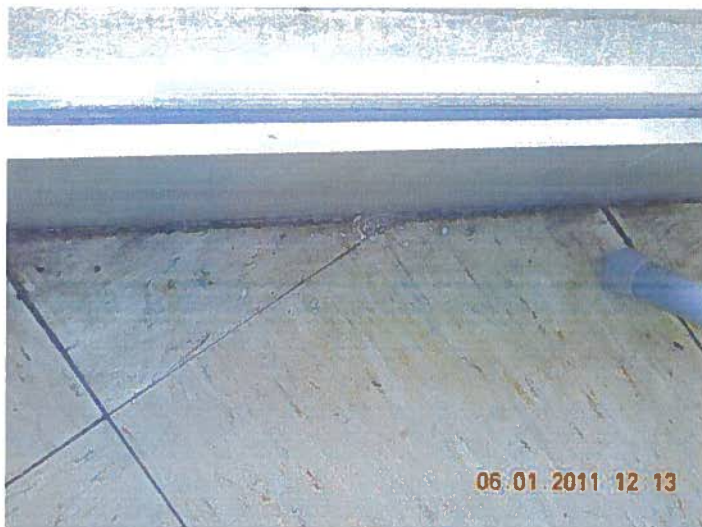
Picture 29. Ceiling sample.

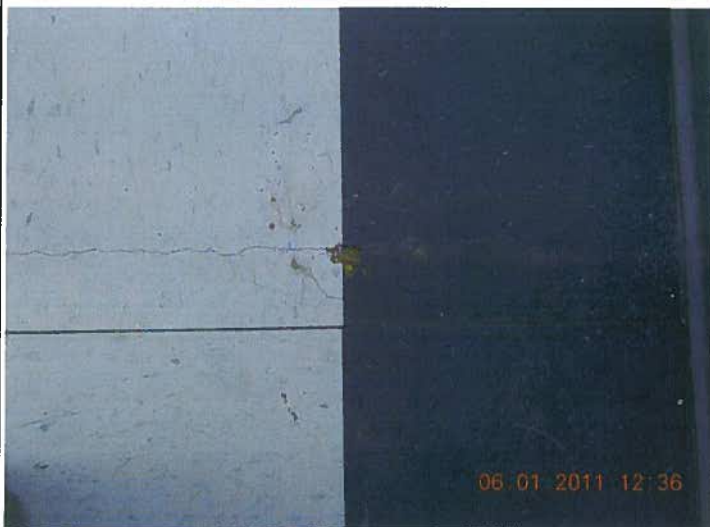
Picture 30. White vinyl tile sample.

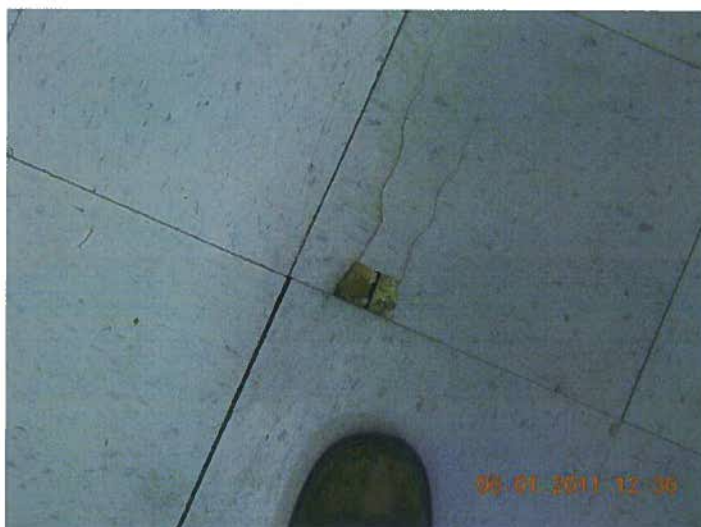
Picture 31. Vinyl tile sample.

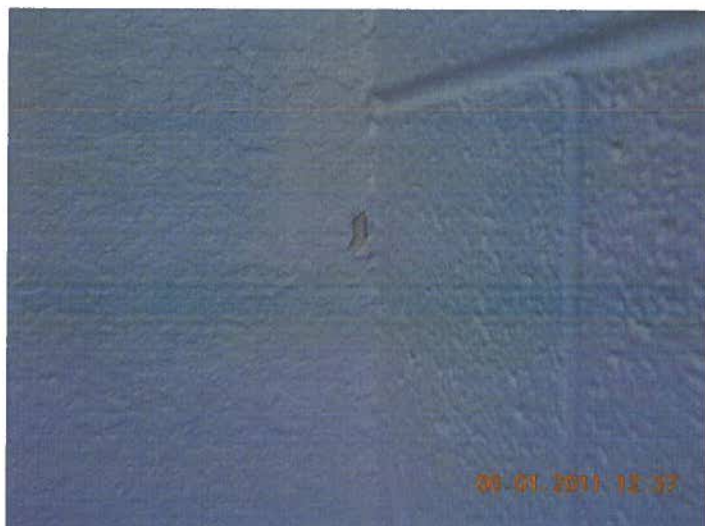
Picture 33. Wallboard sample.

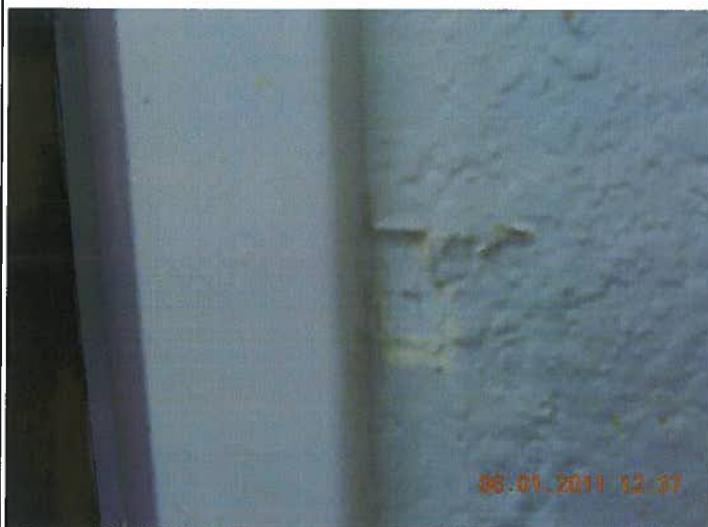
Picture 34. Wallboard sample.

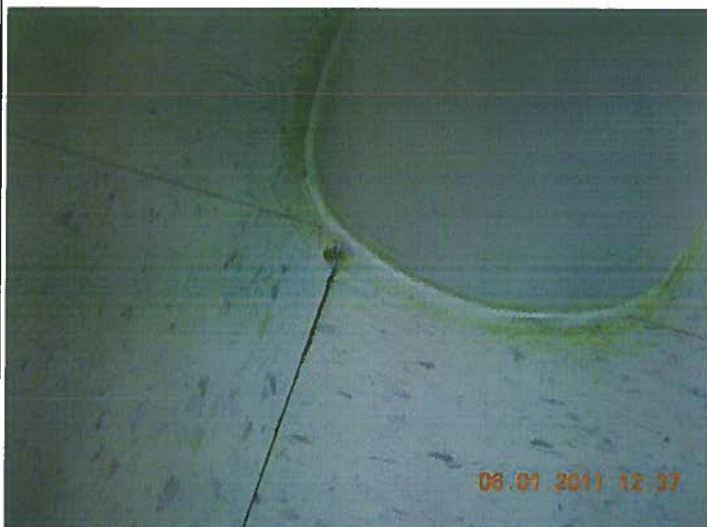
Picture 36. Vinyl tile sample.

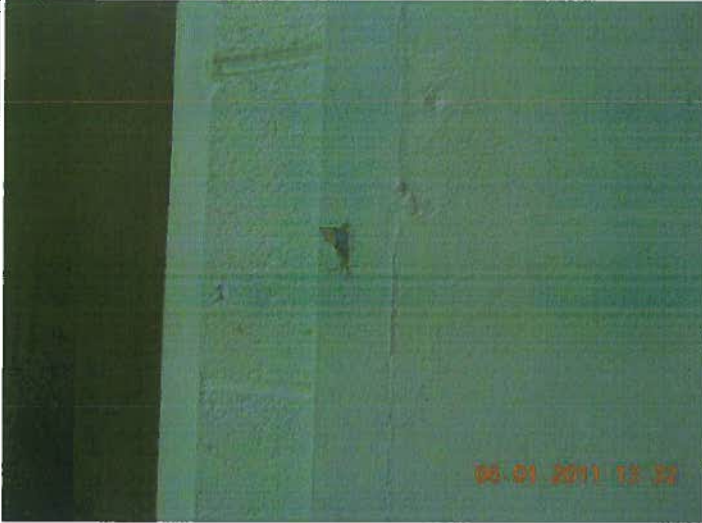
Picture 52. Wallboard sample.

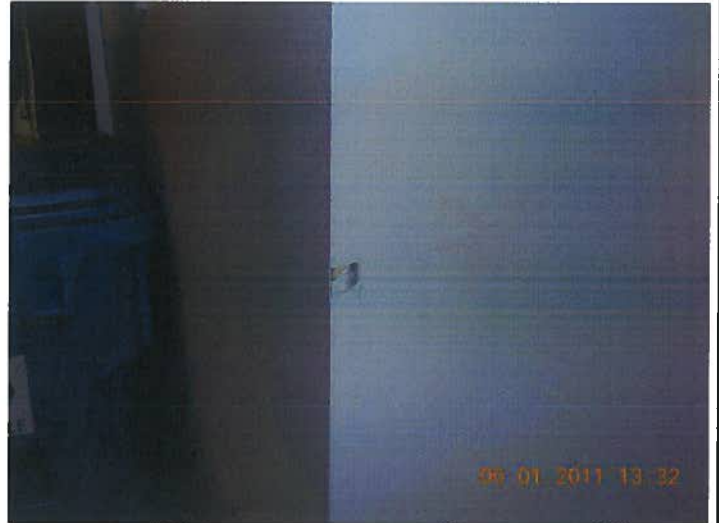
Picture 53. Wallboard sample.

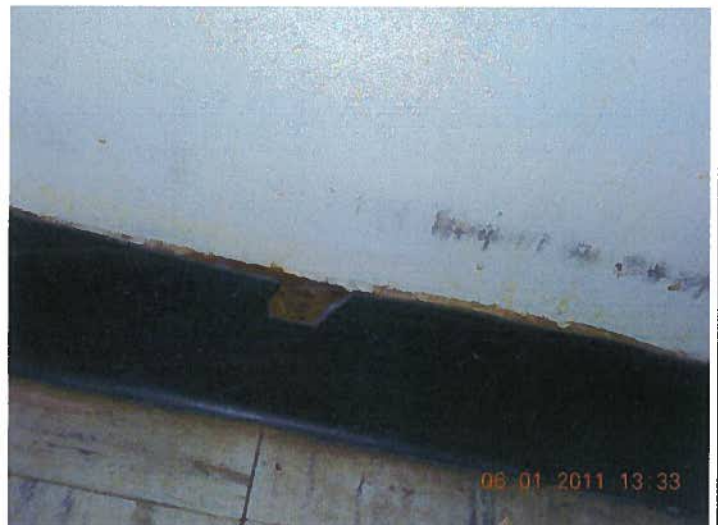
Picture 55. Black cove base sample.

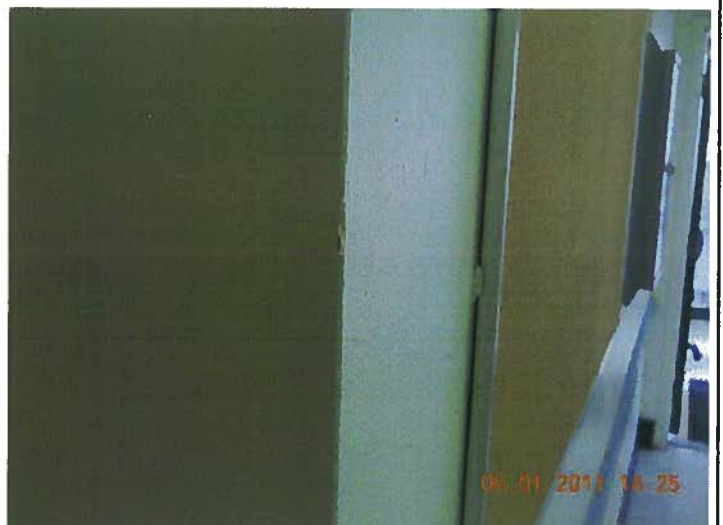
Picture 67. Wallboard sample.

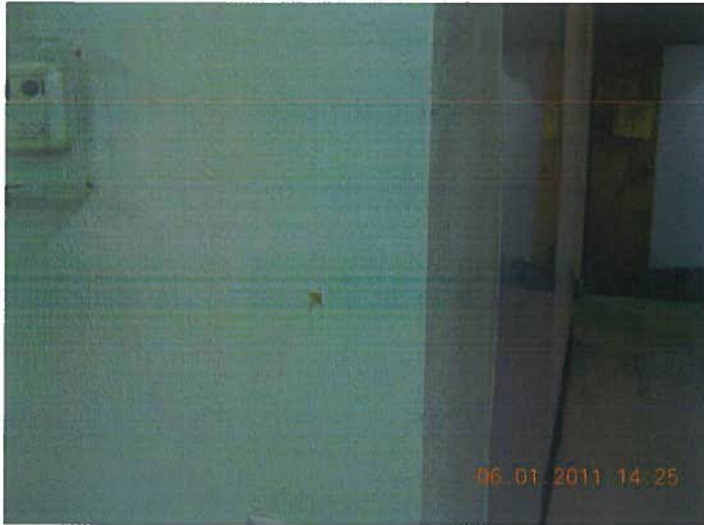
Picture 68. Wallboard sample.

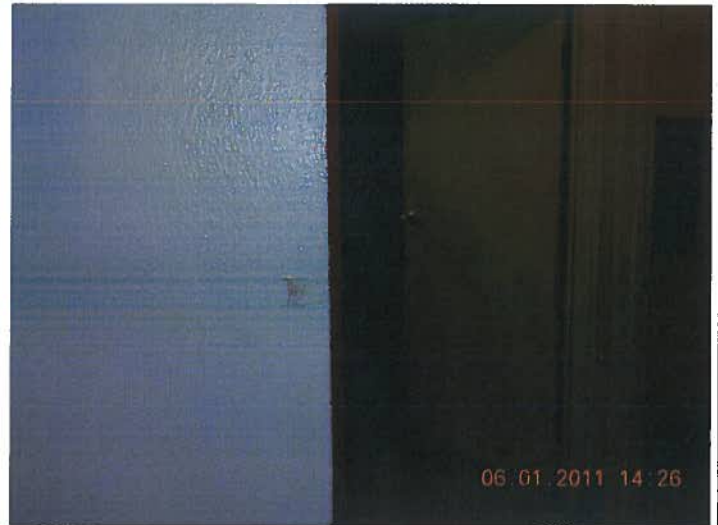
Picture 69. Wallboard sample.

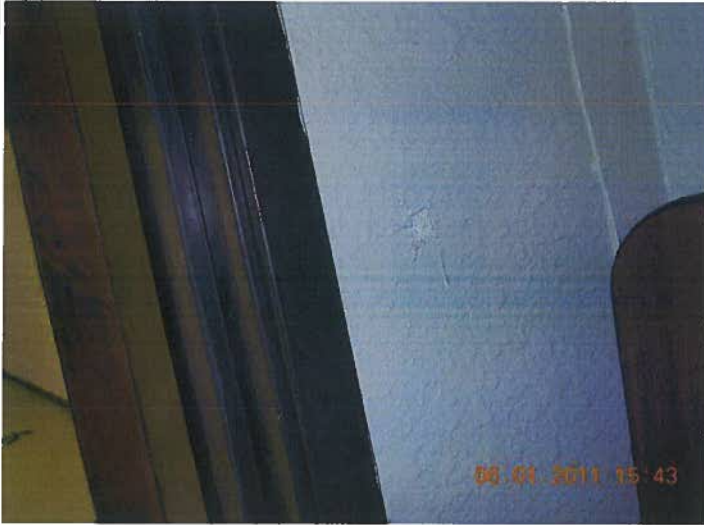
Picture 84. Wallboard sample.

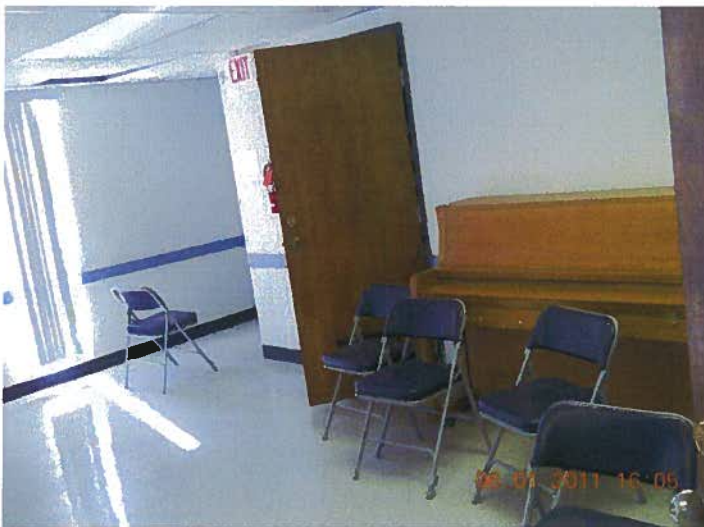
Picture 86. Black cove base sample.

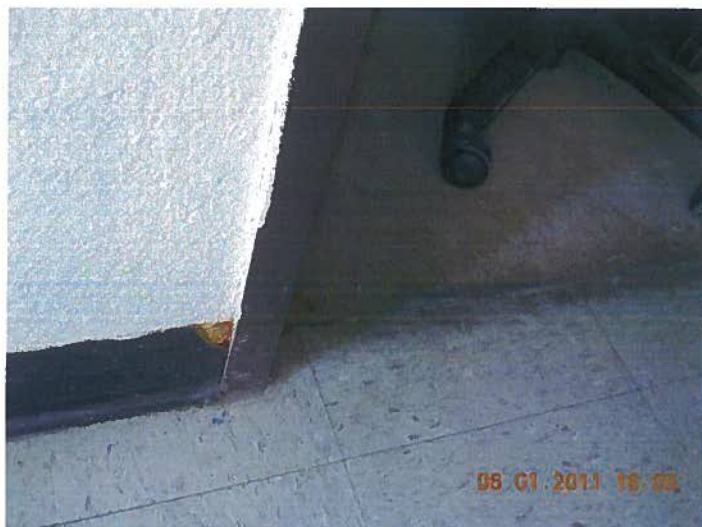
Picture 89. Wallboard sample.

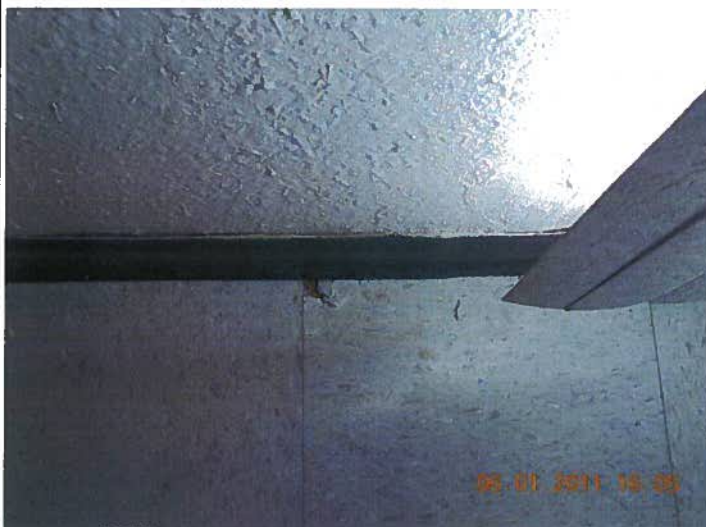
Picture 90. Black cove base sample.

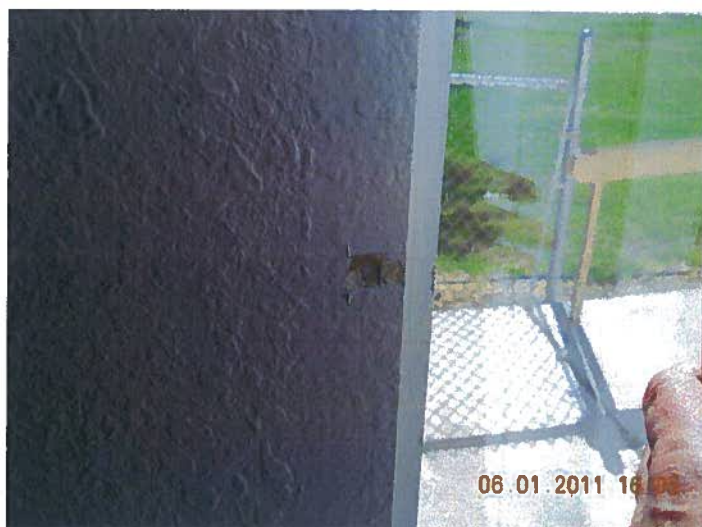
Picture 91. Vinyl tile sample.

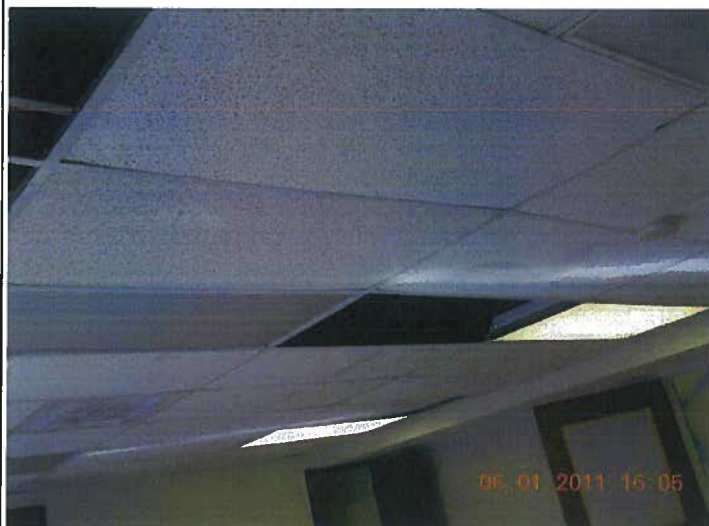
Picture 92. Wallboard sample.

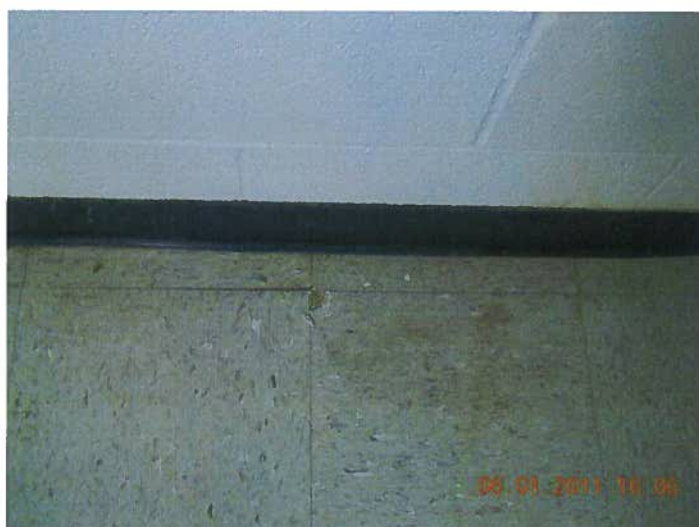
Picture 95. Wallboard sample.

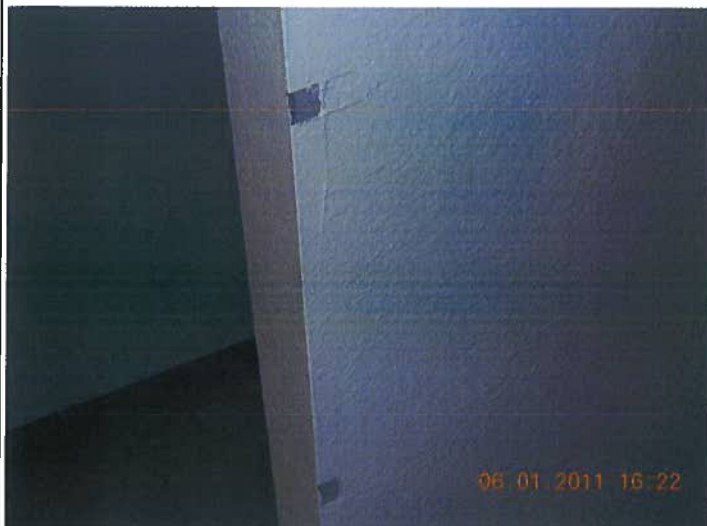
Picture 96. Vinyl tile sample.

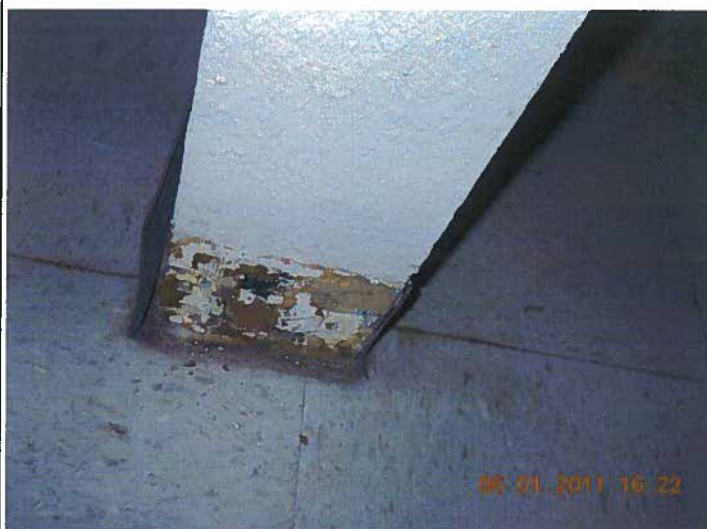
Picture 98. Wallboard sample.
